Walker Fraser Steele
Chartered Surveyors

GRANGE COTTAGE STAFFORD ROAD

Energy Performance Certificate

Dwelling type: Detached bungalow
Date of assessment: 12 June 2023
Date of certificate: 12 June 2023
Total floor area: 192 m²
Primary Energy Indicator: 295 kWh/m²/year

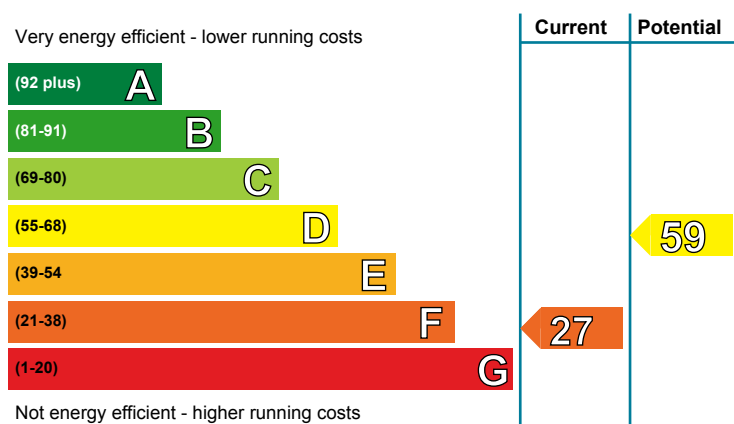
Energy Efficiency Rating

This graph shows the current efficiency of your home, taking into account both energy efficiency and fuel costs. The higher this rating, the lower your fuel bills are likely to be.

Your current rating is **band F (27)**. The average rating for EPCs in Scotland is **band D (61)**.

The potential rating shows the effect of undertaking all of the improvement measures listed within your recommendations report.

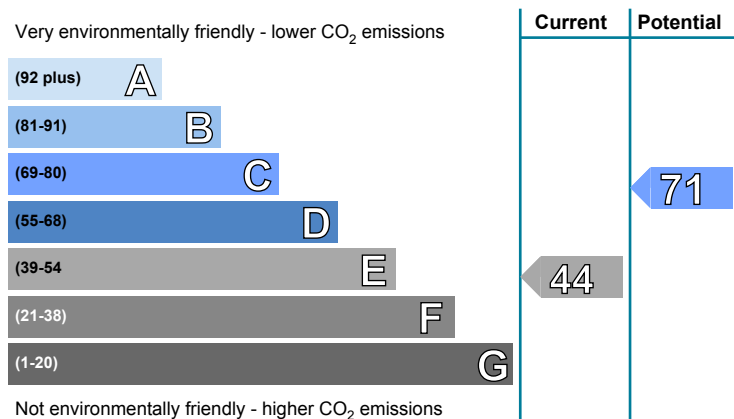
Environmental Impact (CO₂) Rating

This graph shows the effect of your home on the environment in terms of carbon dioxide (CO₂) emissions. The higher the rating, the less impact it has on the environment.

Your current rating is **band E (44)**. The average rating for EPCs in Scotland is **band D (59)**.

The potential rating shows the effect of undertaking all of the improvement measures listed within your recommendations report.
