# **Home Report**

1 BOGBAIN FARM COTTAGES TAIN IV19 1NA

# **Energy Performance Certificate**

#### **BOGBAIN FARM COTTAGES, 1, TAIN, IV19 1NA**

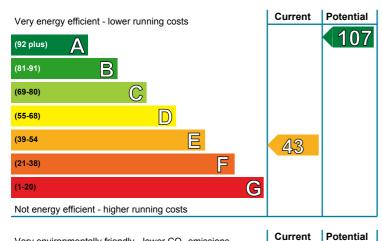
Very environmentally friendly - lower CO<sub>2</sub> emissions

#### **Energy Efficiency Rating**

This graph shows the current efficiency of your home, taking into account both energy efficiency and fuel costs. The higher this rating, the lower your fuel bills are likely to be.

Your current rating is **band E (43)**. The average rating for EPCs in Scotland is band D (61).

The potential rating shows the effect of undertaking all of the improvement measures listed within your recommendations report.
