Home Report

Bunillidh
371 Skelbo
Dornoch
IV25 3QQ

Energy Performance Certificate (EPC)

Dwelling type: Detached bungalow
Date of assessment: 18 March 2026
Date of certificate: 06 April 2026
Total floor area: 132 m²
Primary Energy Indicator: 243 kWh/m²/year

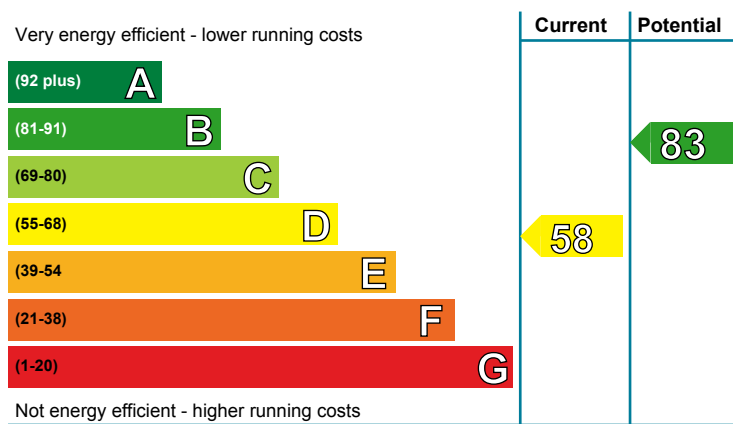
Energy Efficiency Rating

This graph shows the current efficiency of your home, taking into account both energy efficiency and fuel costs. The higher this rating, the lower your fuel bills are likely to be.

Your current rating is **band D (58)**. The average rating for EPCs in Scotland is **band D (61)**.

The potential rating shows the effect of undertaking all of the improvement measures listed within your recommendations report.

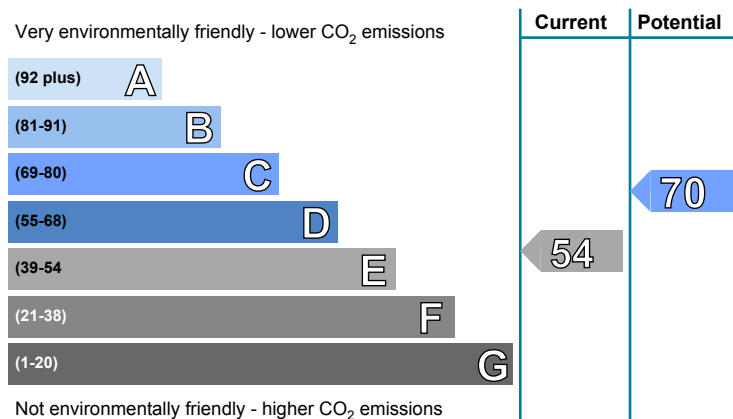
Environmental Impact (CO₂) Rating

This graph shows the effect of your home on the environment in terms of carbon dioxide (CO₂) emissions. The higher the rating, the less impact it has on the environment.

Your current rating is **band E (54)**

The potential rating shows the effect of undertaking all of the improvement measures listed within your recommendations report.

The average Scottish household produces about 6 tonnes of carbon dioxide every year. Based on this assessment, heating and lighting this home currently produces approximately 7.1 tonnes of carbon dioxide every year. Adopting recommendations in this report can reduce emissions and protect the environment. If you were to install all of these recommendations this could reduce emissions by 2.3 tonnes per year. You could reduce emissions even more by switching to renewable energy sources.
