Home Report

INCHARD HOUSE RHICONICH

LAIRG
IV27 4RN

Energy Performance Certificate

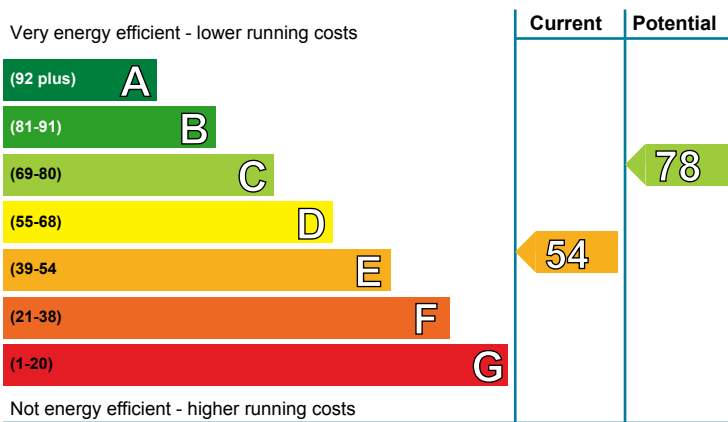
Energy Efficiency Rating

This graph shows the current efficiency of your home, taking into account both energy efficiency and fuel costs. The higher this rating, the lower your fuel bills are likely to be.

Your current rating is **band E (54)**. The average rating for EPCs in Scotland is **band D (61)**.

The potential rating shows the effect of undertaking all of the improvement measures listed within your recommendations report.

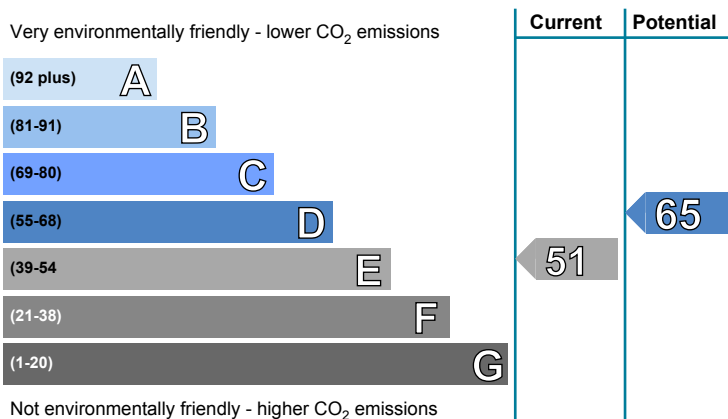
Environmental Impact (CO₂) Rating

This graph shows the effect of your home on the environment in terms of carbon dioxide (CO₂) emissions. The higher the rating, the less impact it has on the environment.

Your current rating is **band E (51)**

The potential rating shows the effect of undertaking all of the improvement measures listed within your recommendations report.
