# Home Report

# Single Survey

| <b>Property Address</b> | Golf View Cnoc An Lobht Dornoch IV25 3HN |

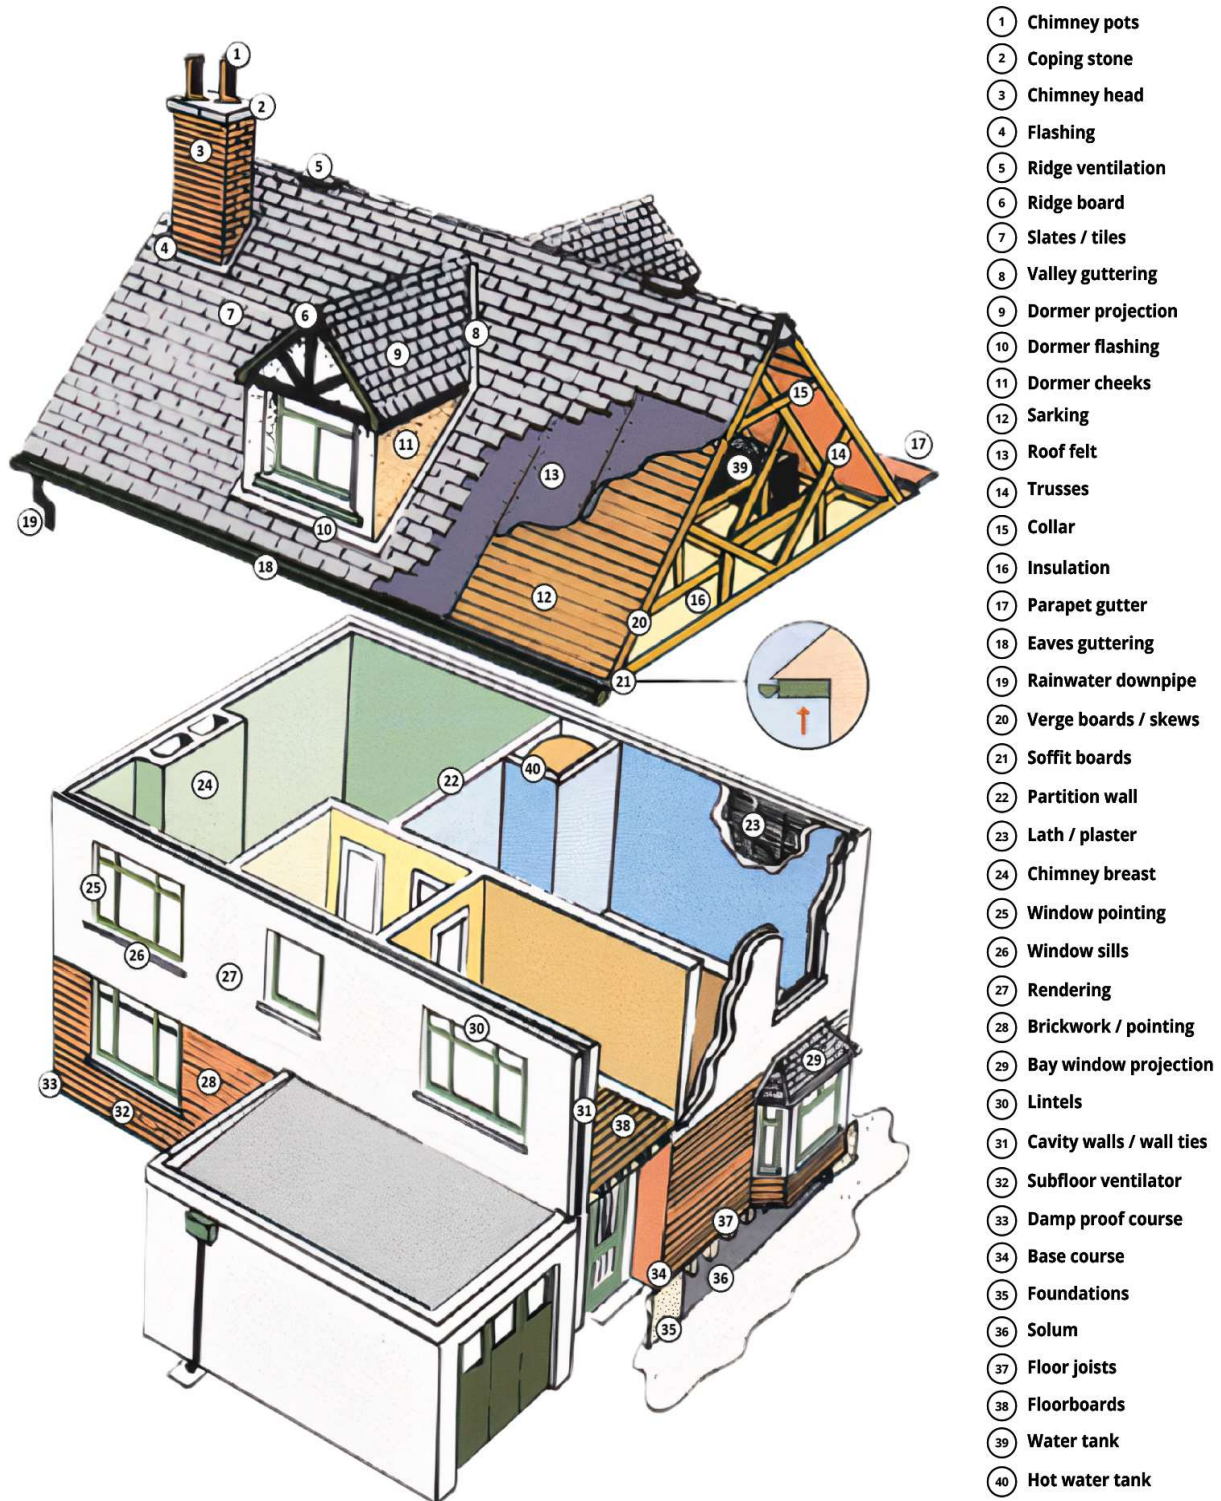
## Sectional Diagram showing elements of a typical house

Reference may be made in this report to some or all of the above component parts of the property. This diagram may assist you in locating and understanding these items.

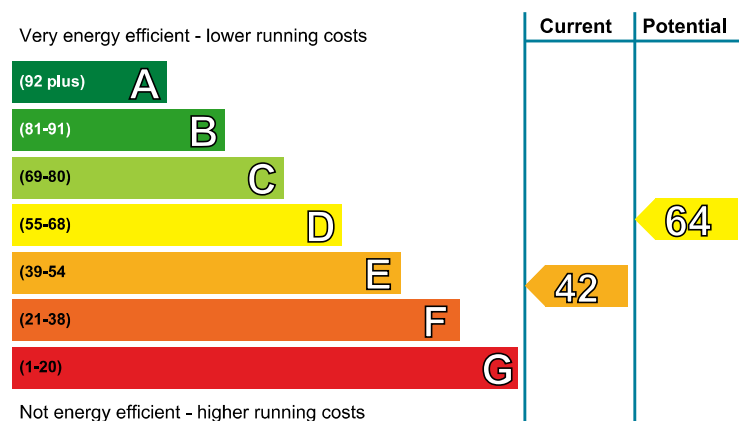
## Energy Efficiency Rating

This graph shows the current efficiency of your home, taking into account both energy efficiency and fuel costs. The higher this rating, the lower your fuel bills are likely to be.

Your current rating is **band E (42)**. The average rating for EPCs in Scotland is **band D (61)**.

The potential rating shows the effect of undertaking all of the improvement measures listed within your recommendations report.

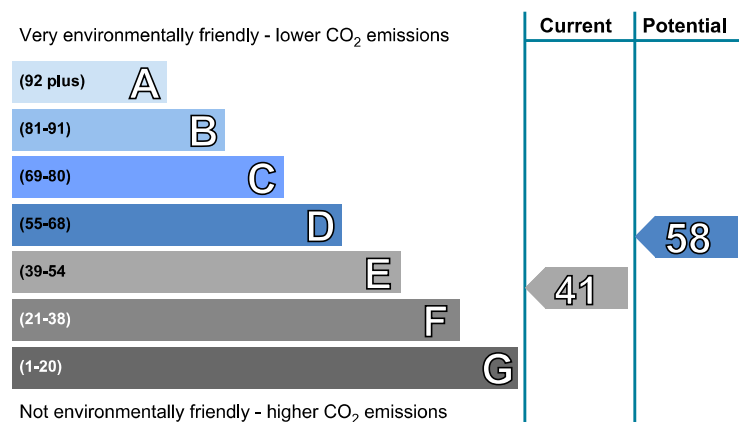
## Environmental Impact (CO<sub>2</sub>) Rating

This graph shows the effect of your home on the environment in terms of carbon dioxide (CO<sub>2</sub>) emissions. The higher the rating, the less impact it has on the environment.
